# CASPIAN LAKE DAM

VT 00183

## PHASE I INSPECTION REPORT NATIONAL DAM INSPECTION PROGRAM

JANUARY 1979

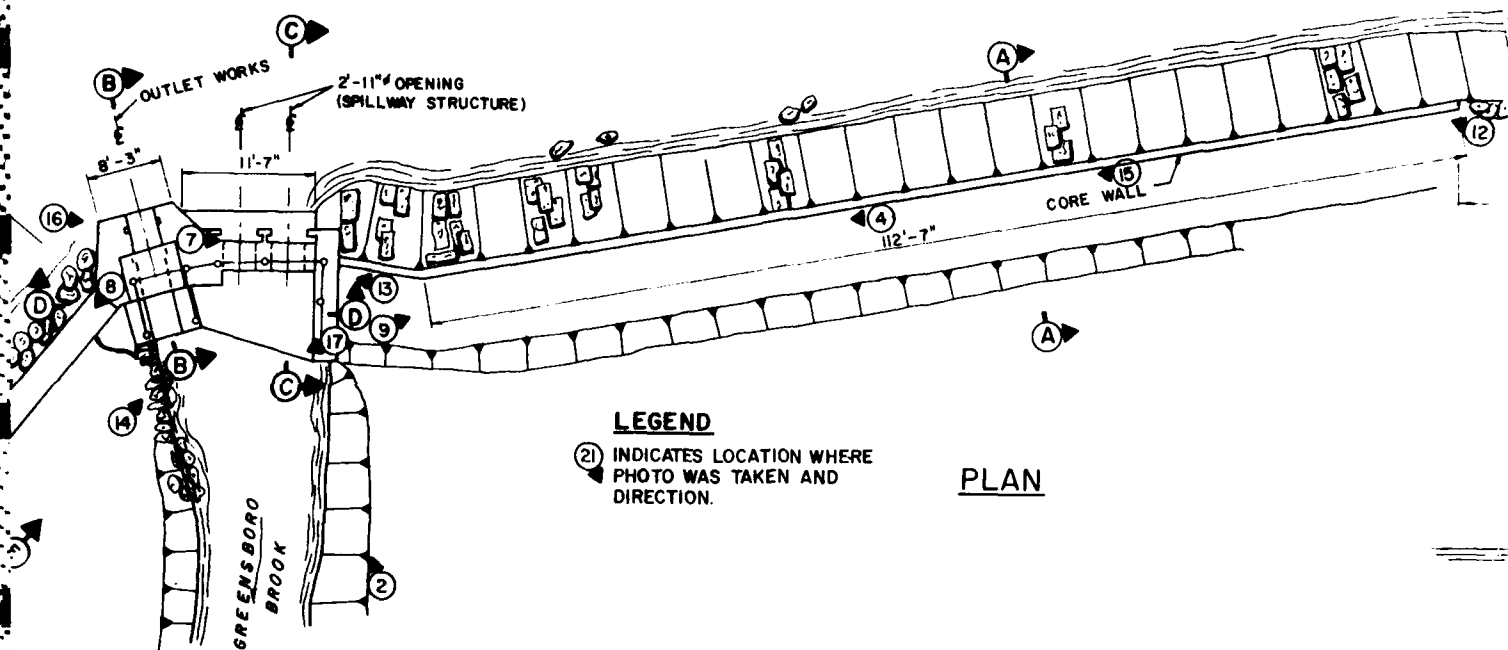
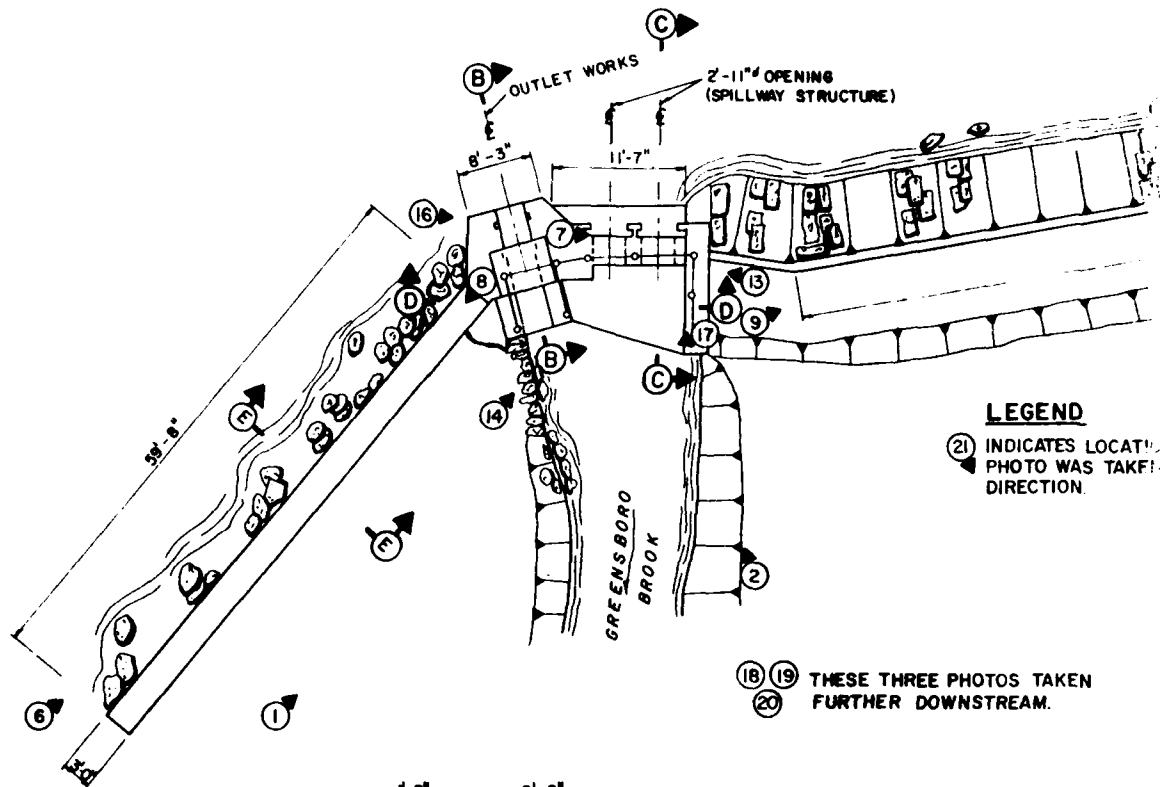
Figure 1, located in Appendix B, shows the plan of the dam and its appurtenant structures. Photographs of each structure are shown in Appendix C.

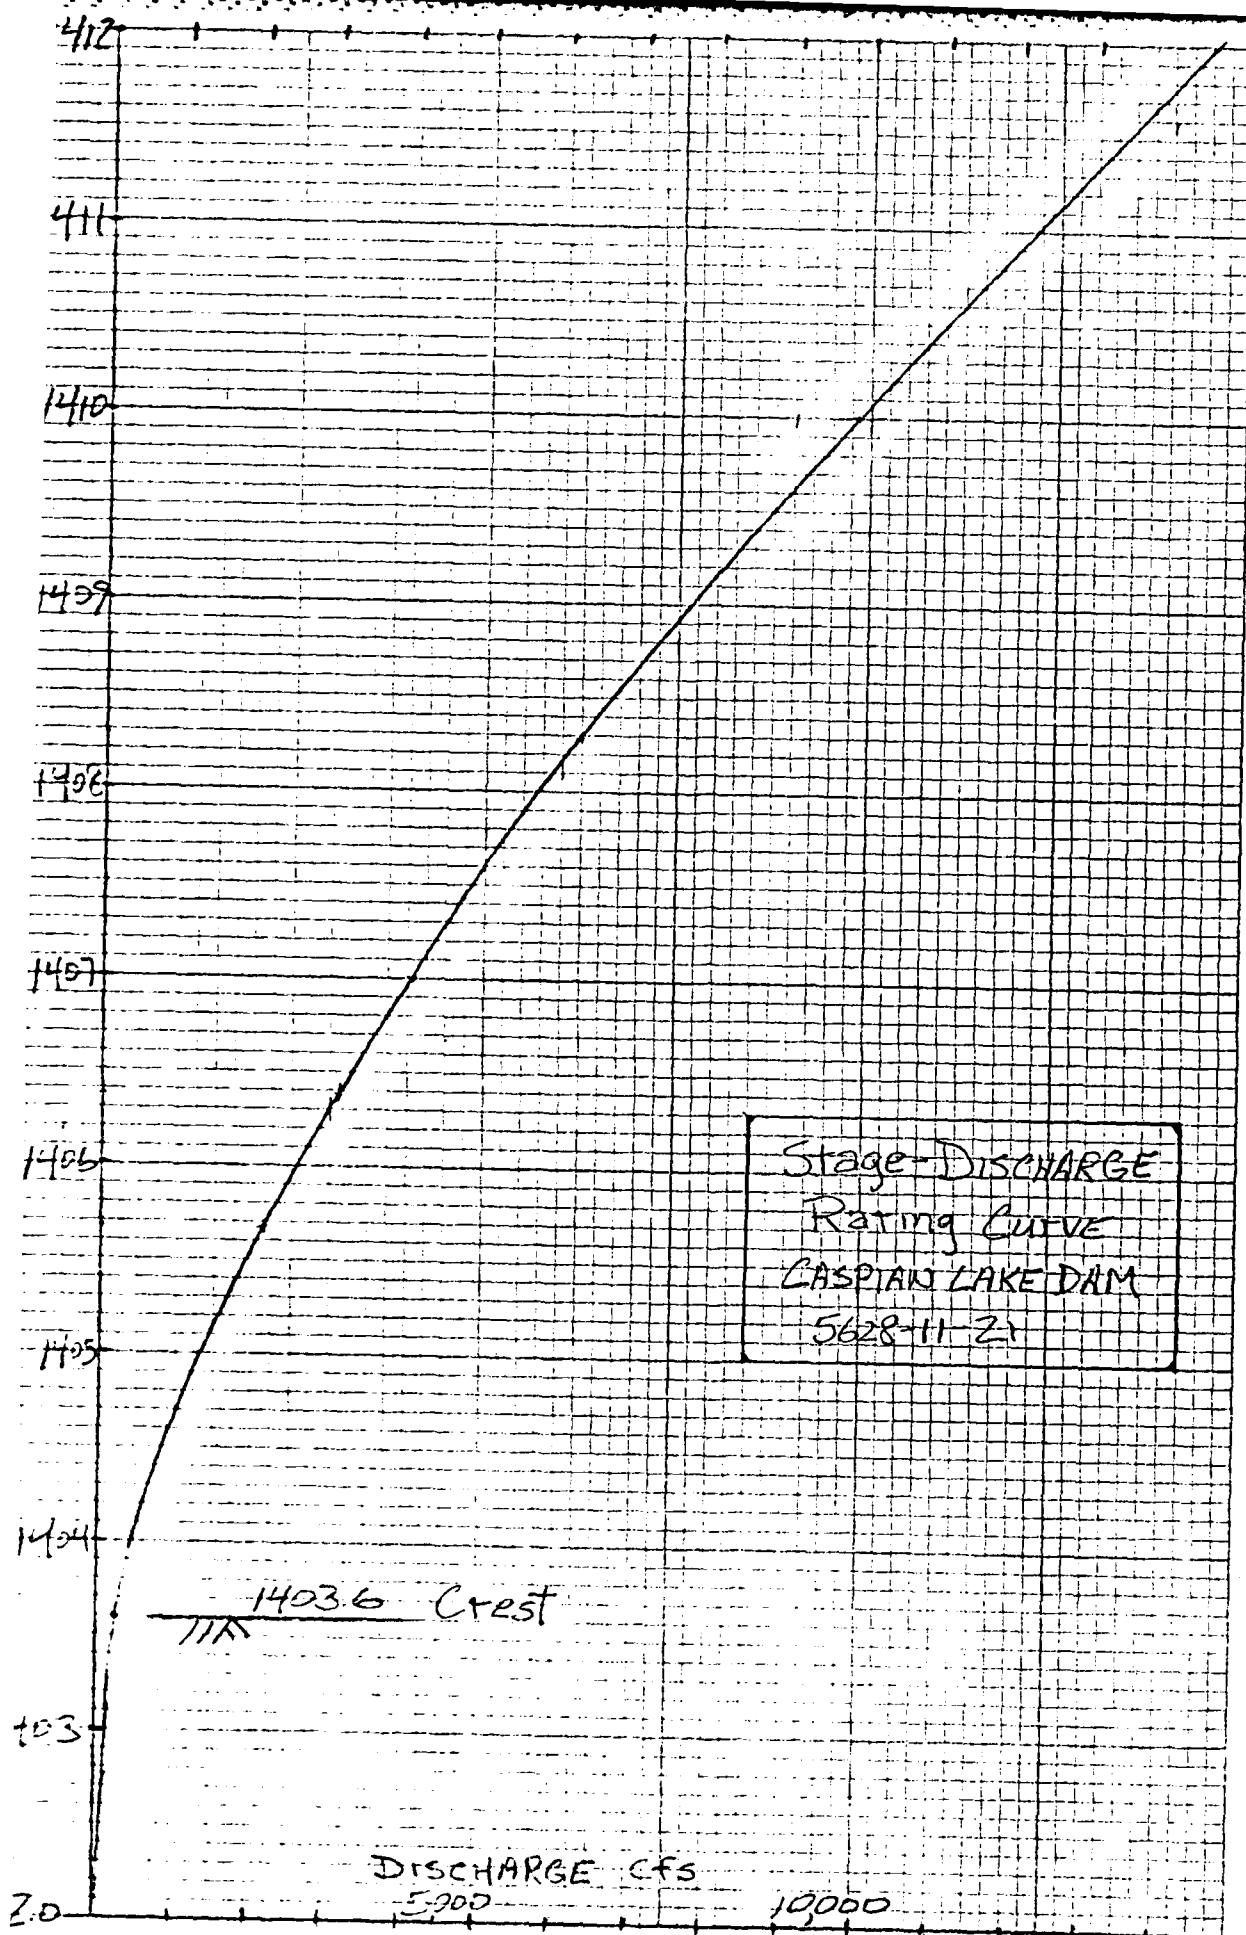
FIG. 1

The spillway & storage capacity can safely pass 6.0% of the test flood.

At the test flood discharge of 2177 cfs the dam crest will be overtopped by 2.08 ft.
